### HYDROGEN-OXYGEN ELECTROLYTIC REGENERATIVE FUEL CELLS

Contract NAS 3-2781

EOS Report 4110-2Q-1

26 July, 1964

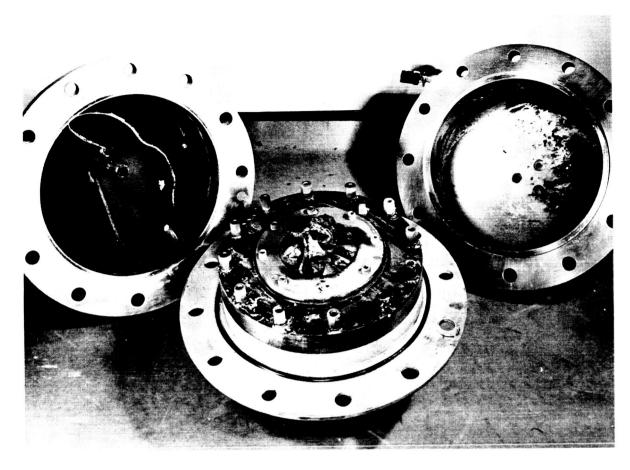
FIG. 7 FUEL CELL AFTER TYPICAL INTERNAL IGNITION

At the end of the fifth cycle another malfunction occurred within the unit. A slight noise was heard, the gas pressures and temperature rose suddenly, and the discharge voltage and current slowly dropped to zero. Disassembly and examination of the unit revealed signs of another internal ignition. (See Fig. 7)

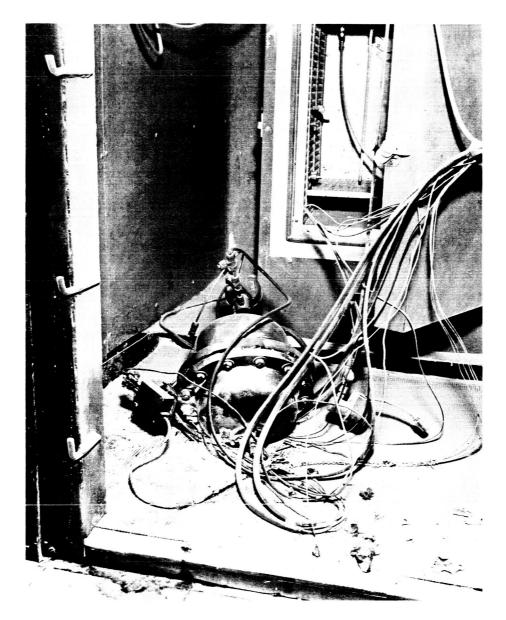
FIG. 17 FUEL CELL IN TEST CHAMBER AFTER EXPLOSION

The results of this test are given in Figure 15. Performance appeared to be satisfactory during the first few cycles, i.e., 12 amp. discharge at 5 volts. At the start of the fourth discharge period with internal pressure near 300 psig, and temperature near  $70^{\circ}$ C another ignition occurred. This ignition was much more severe than any of the others in that the gases escaped externally and the magnesium  $0_2$  end plate ignited. The door of the test chamber was also blown open during the process (See Fig. 17). The subsequent magnesium fire was extinguished with the aid of chemical fire extinguishers. Disassembly and inspection of the unit revealed severe damage to the end plates and tanks (See Figs. 18, 19, and 20).

Review of all assembly and operating records for this run as well as a thorough inspection of the unit revealed the most probable mode of failure. A short section of mylon tubing was employed on the  $\rm H_2$  leg of the differential pressure transducer instead of copper or steel due to the necessity of insulating the two cell

halves. Although this nylon tubing has a considerably higher burst strength than the operating cell pressure, it is believed to have failed due to overheating by the external heater. The failure of this tubing would have suddenly released hydrogen, causing an excessive internal oxygen differential, and subsequent mixing and ignition.

Elimination of all plastic pressure tubing from the test environment will eliminate a repetition of the type of failure which damaged the 75 watt test model.

The failure mode of the 75 watt model indicated a serious design deficiency. By using a magnesium plate extending between the tank flanges as the cell stack gas seal and positioner, the cell container
